Title: Erosion-control Intervention Associated With Pond Catchment Rehabilitation in Borana Plateau, Ethiopia.

First author: Demisachew Tadele (MSc)  
 Organization: Oromia Agricultural Research Institute;  
 Yabello Pastoral And Dryland Agriculture Research Center.

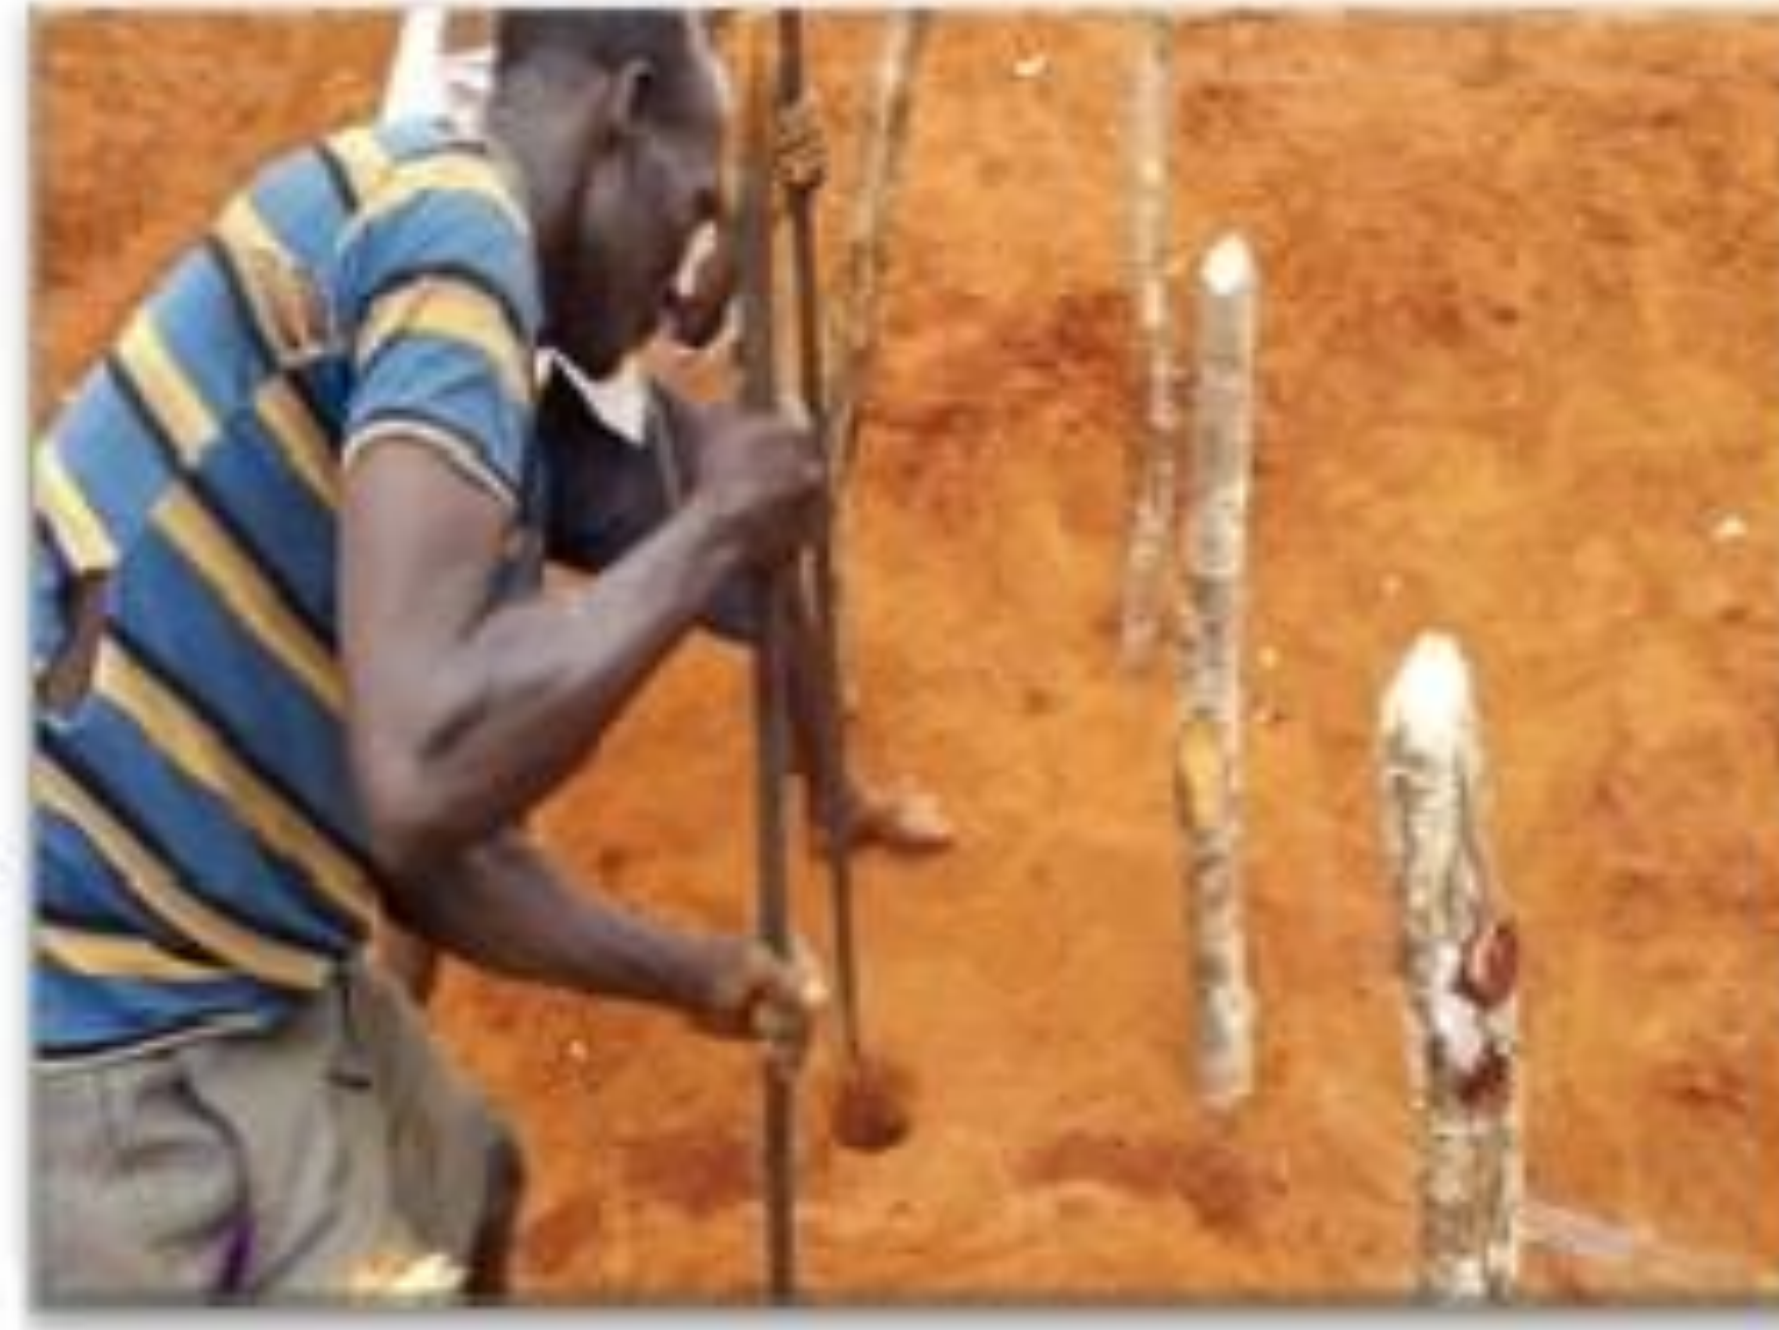
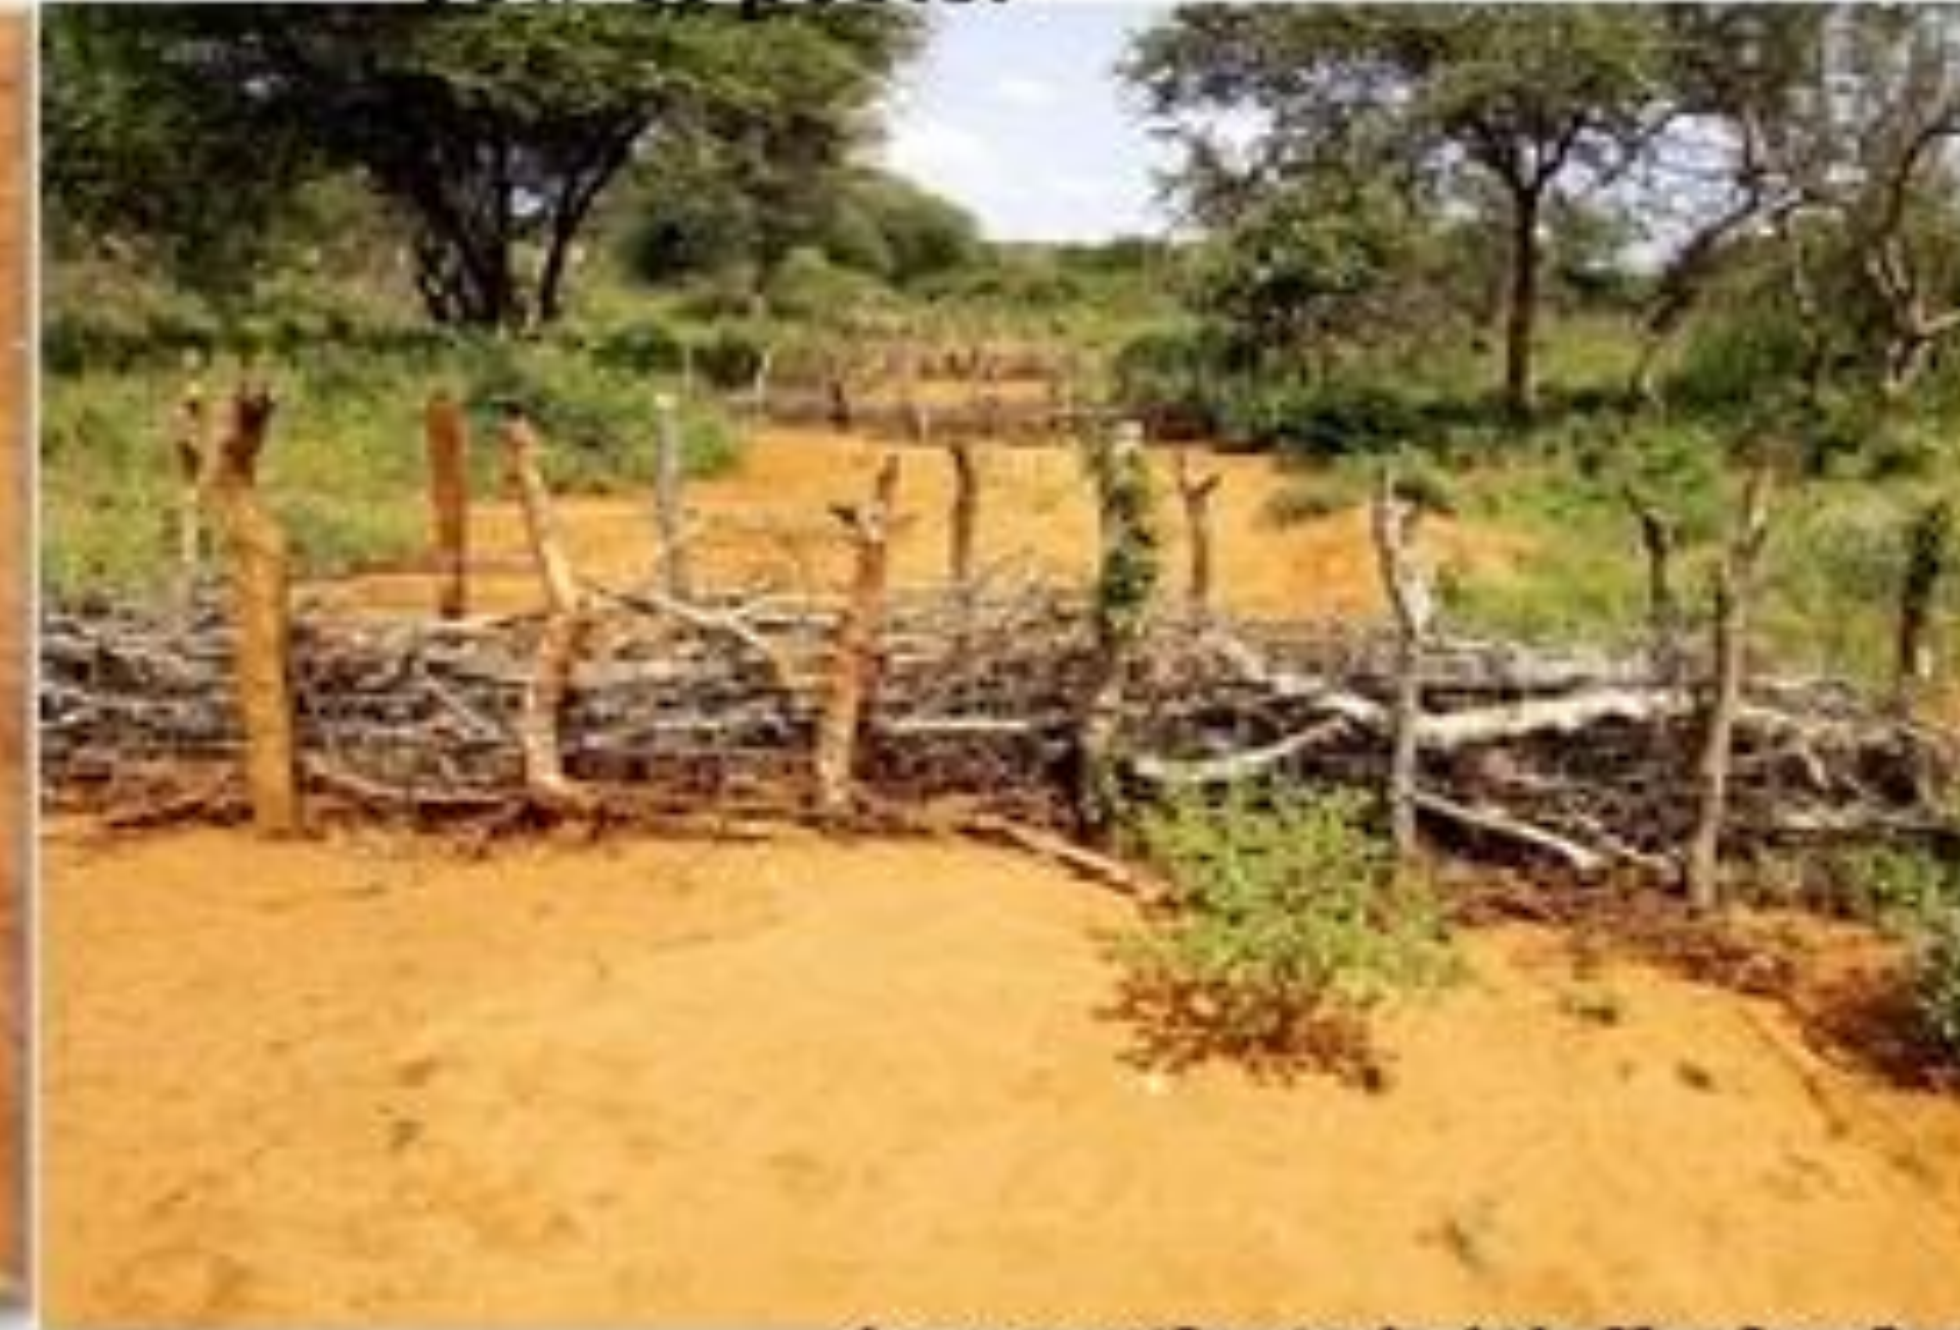
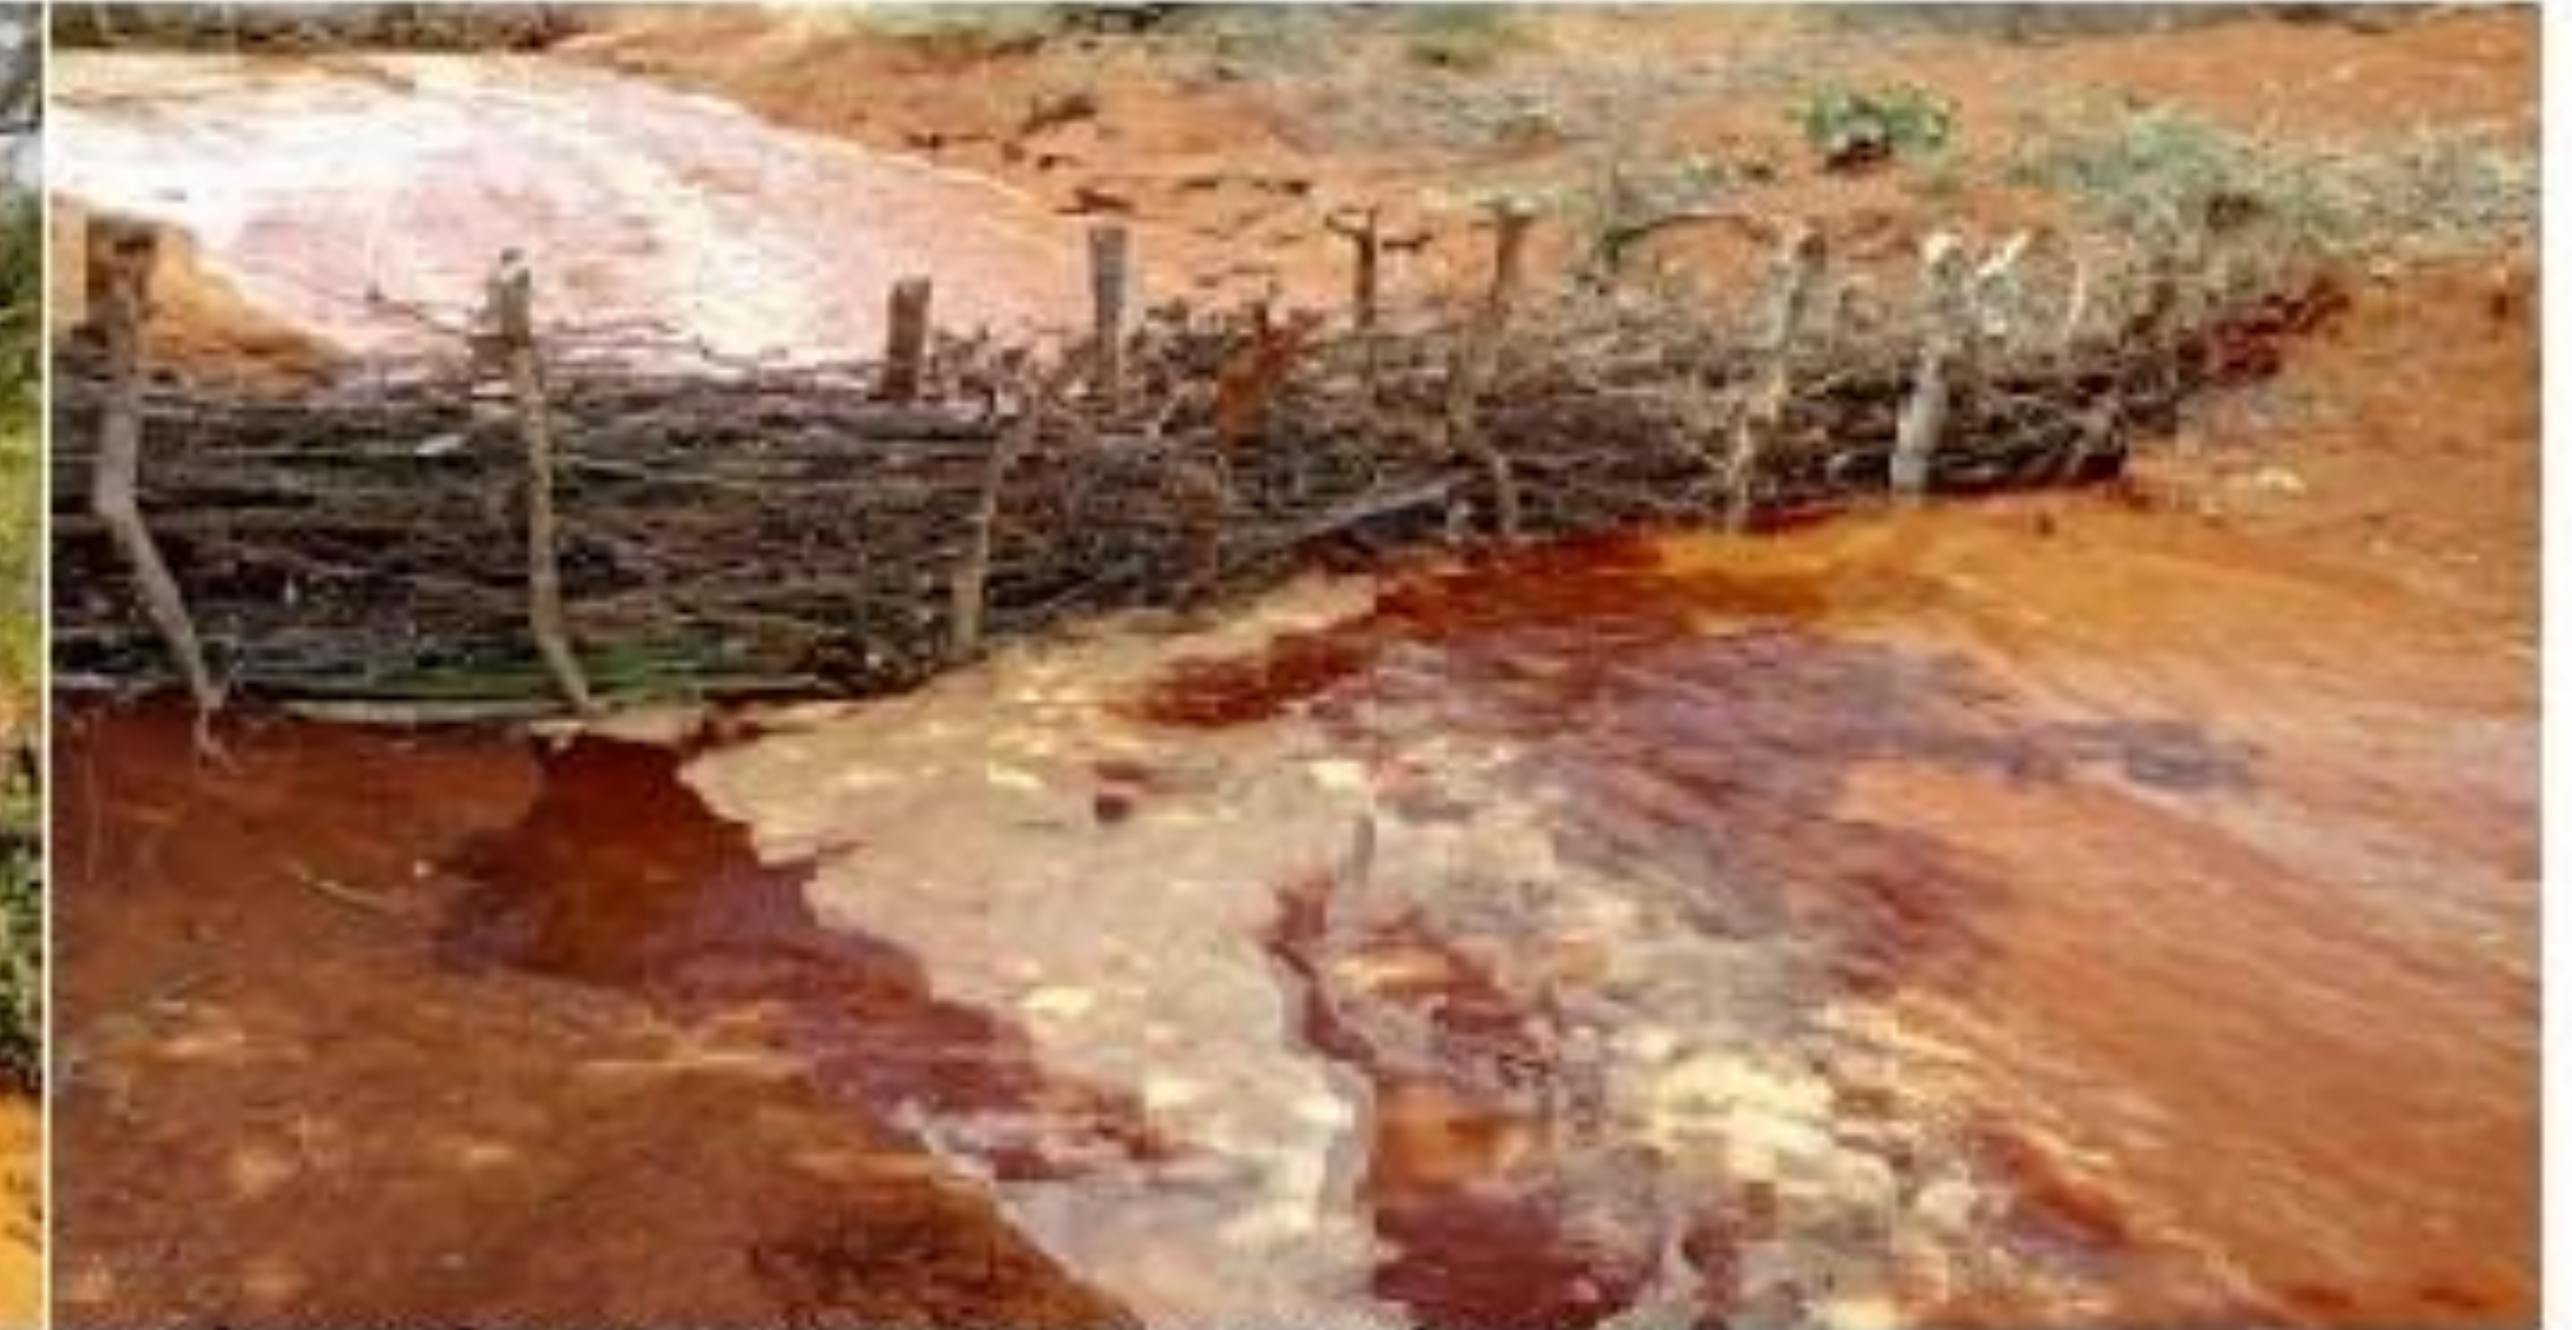
-Buried into gully floor & rising 50-150cm above it.  
 -Gaps of 10-15cm are left b/n th upright posts.

- Branches are then packed horizontally upstream against the row of posts.

-Photo shows when sieve dam structures slow down runoff flow in the gully.

-Sediments filtered/sieved after rainfall events before reaching community pond.

-Measuring the accumulated sediment using graduated stick meter.

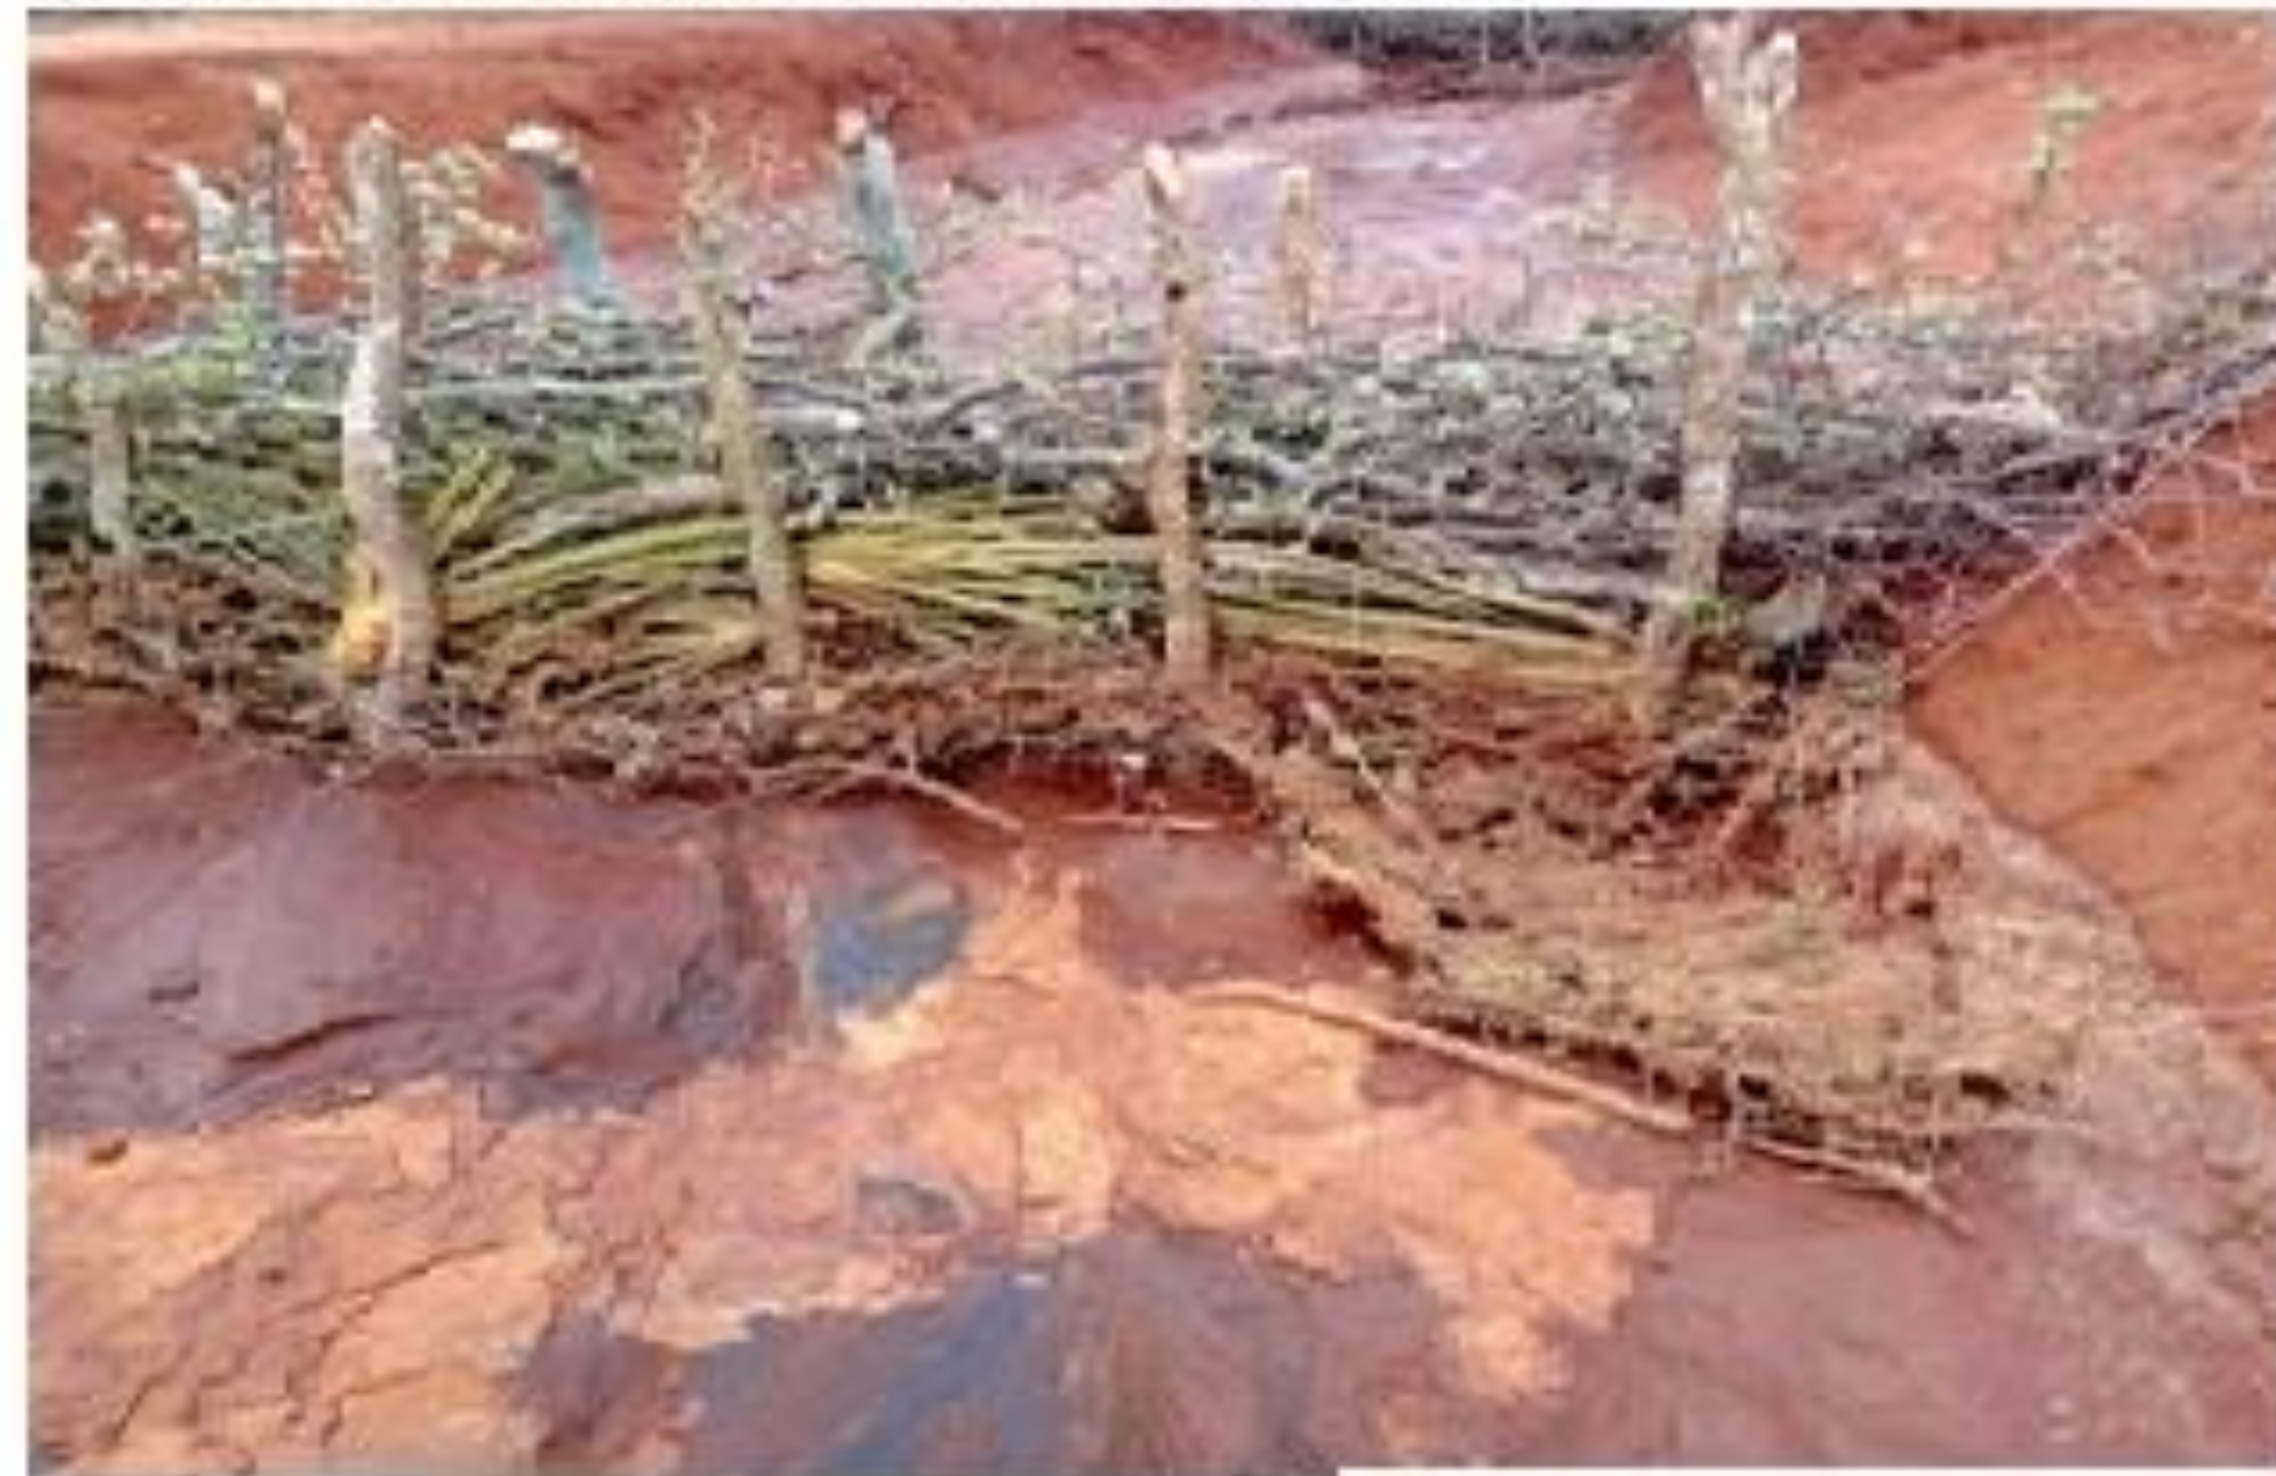
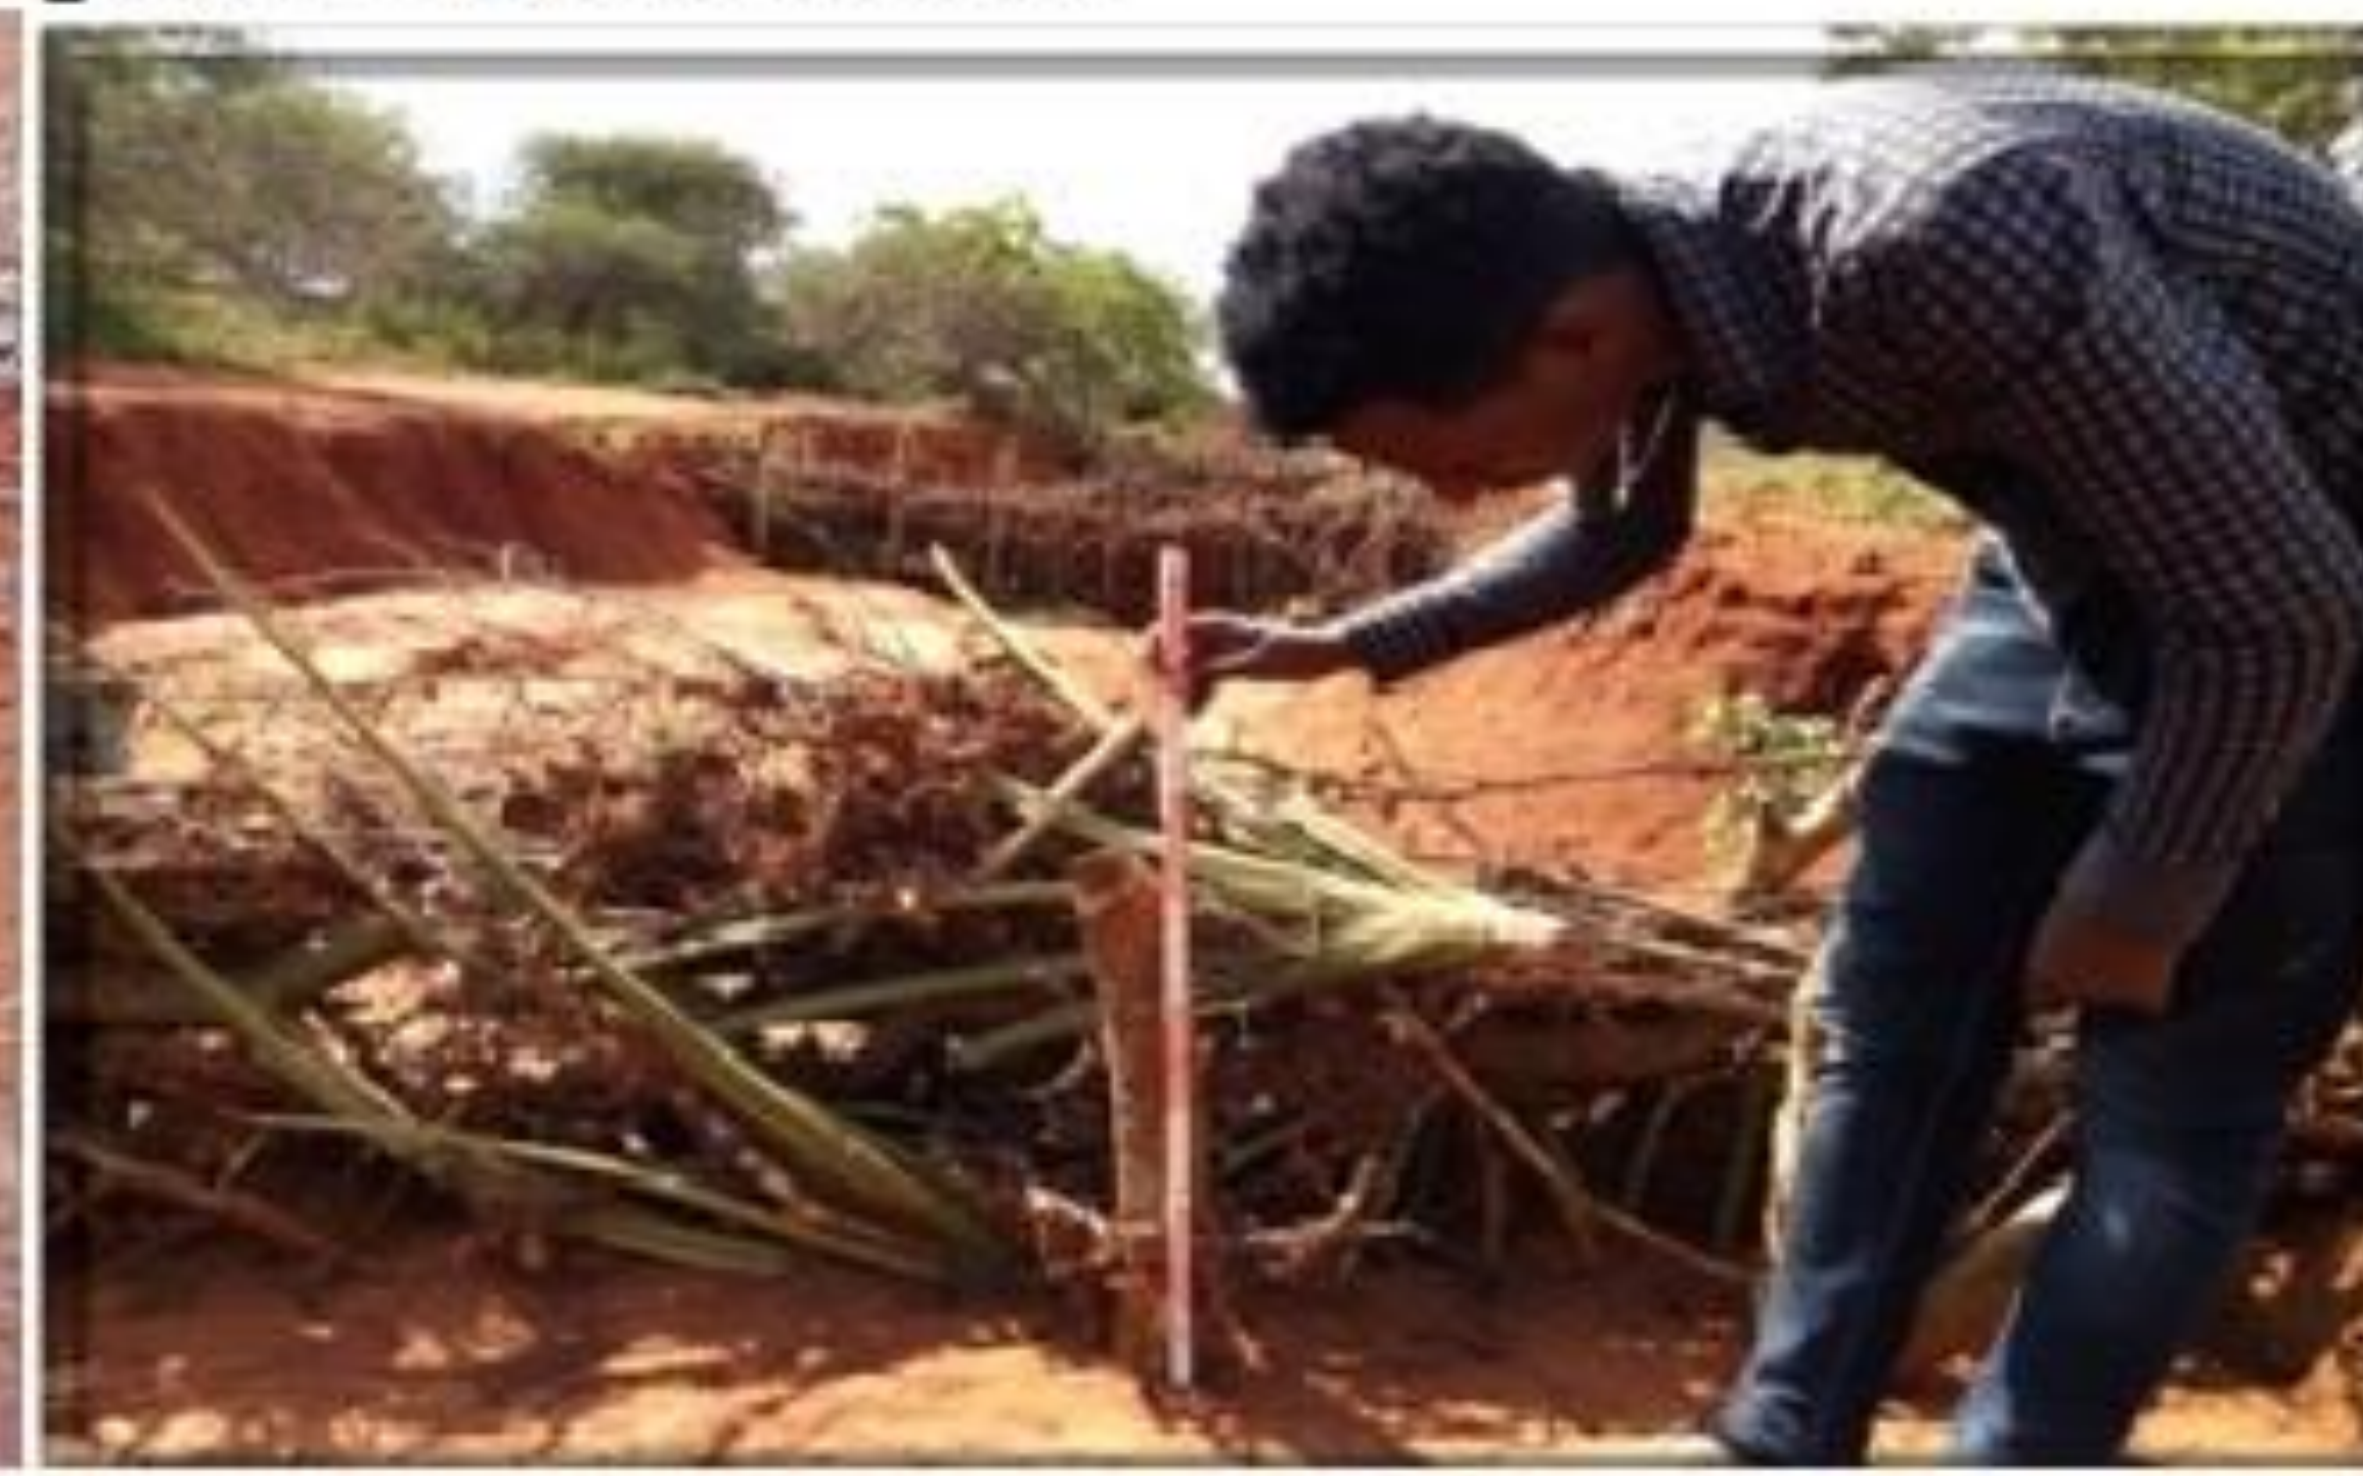
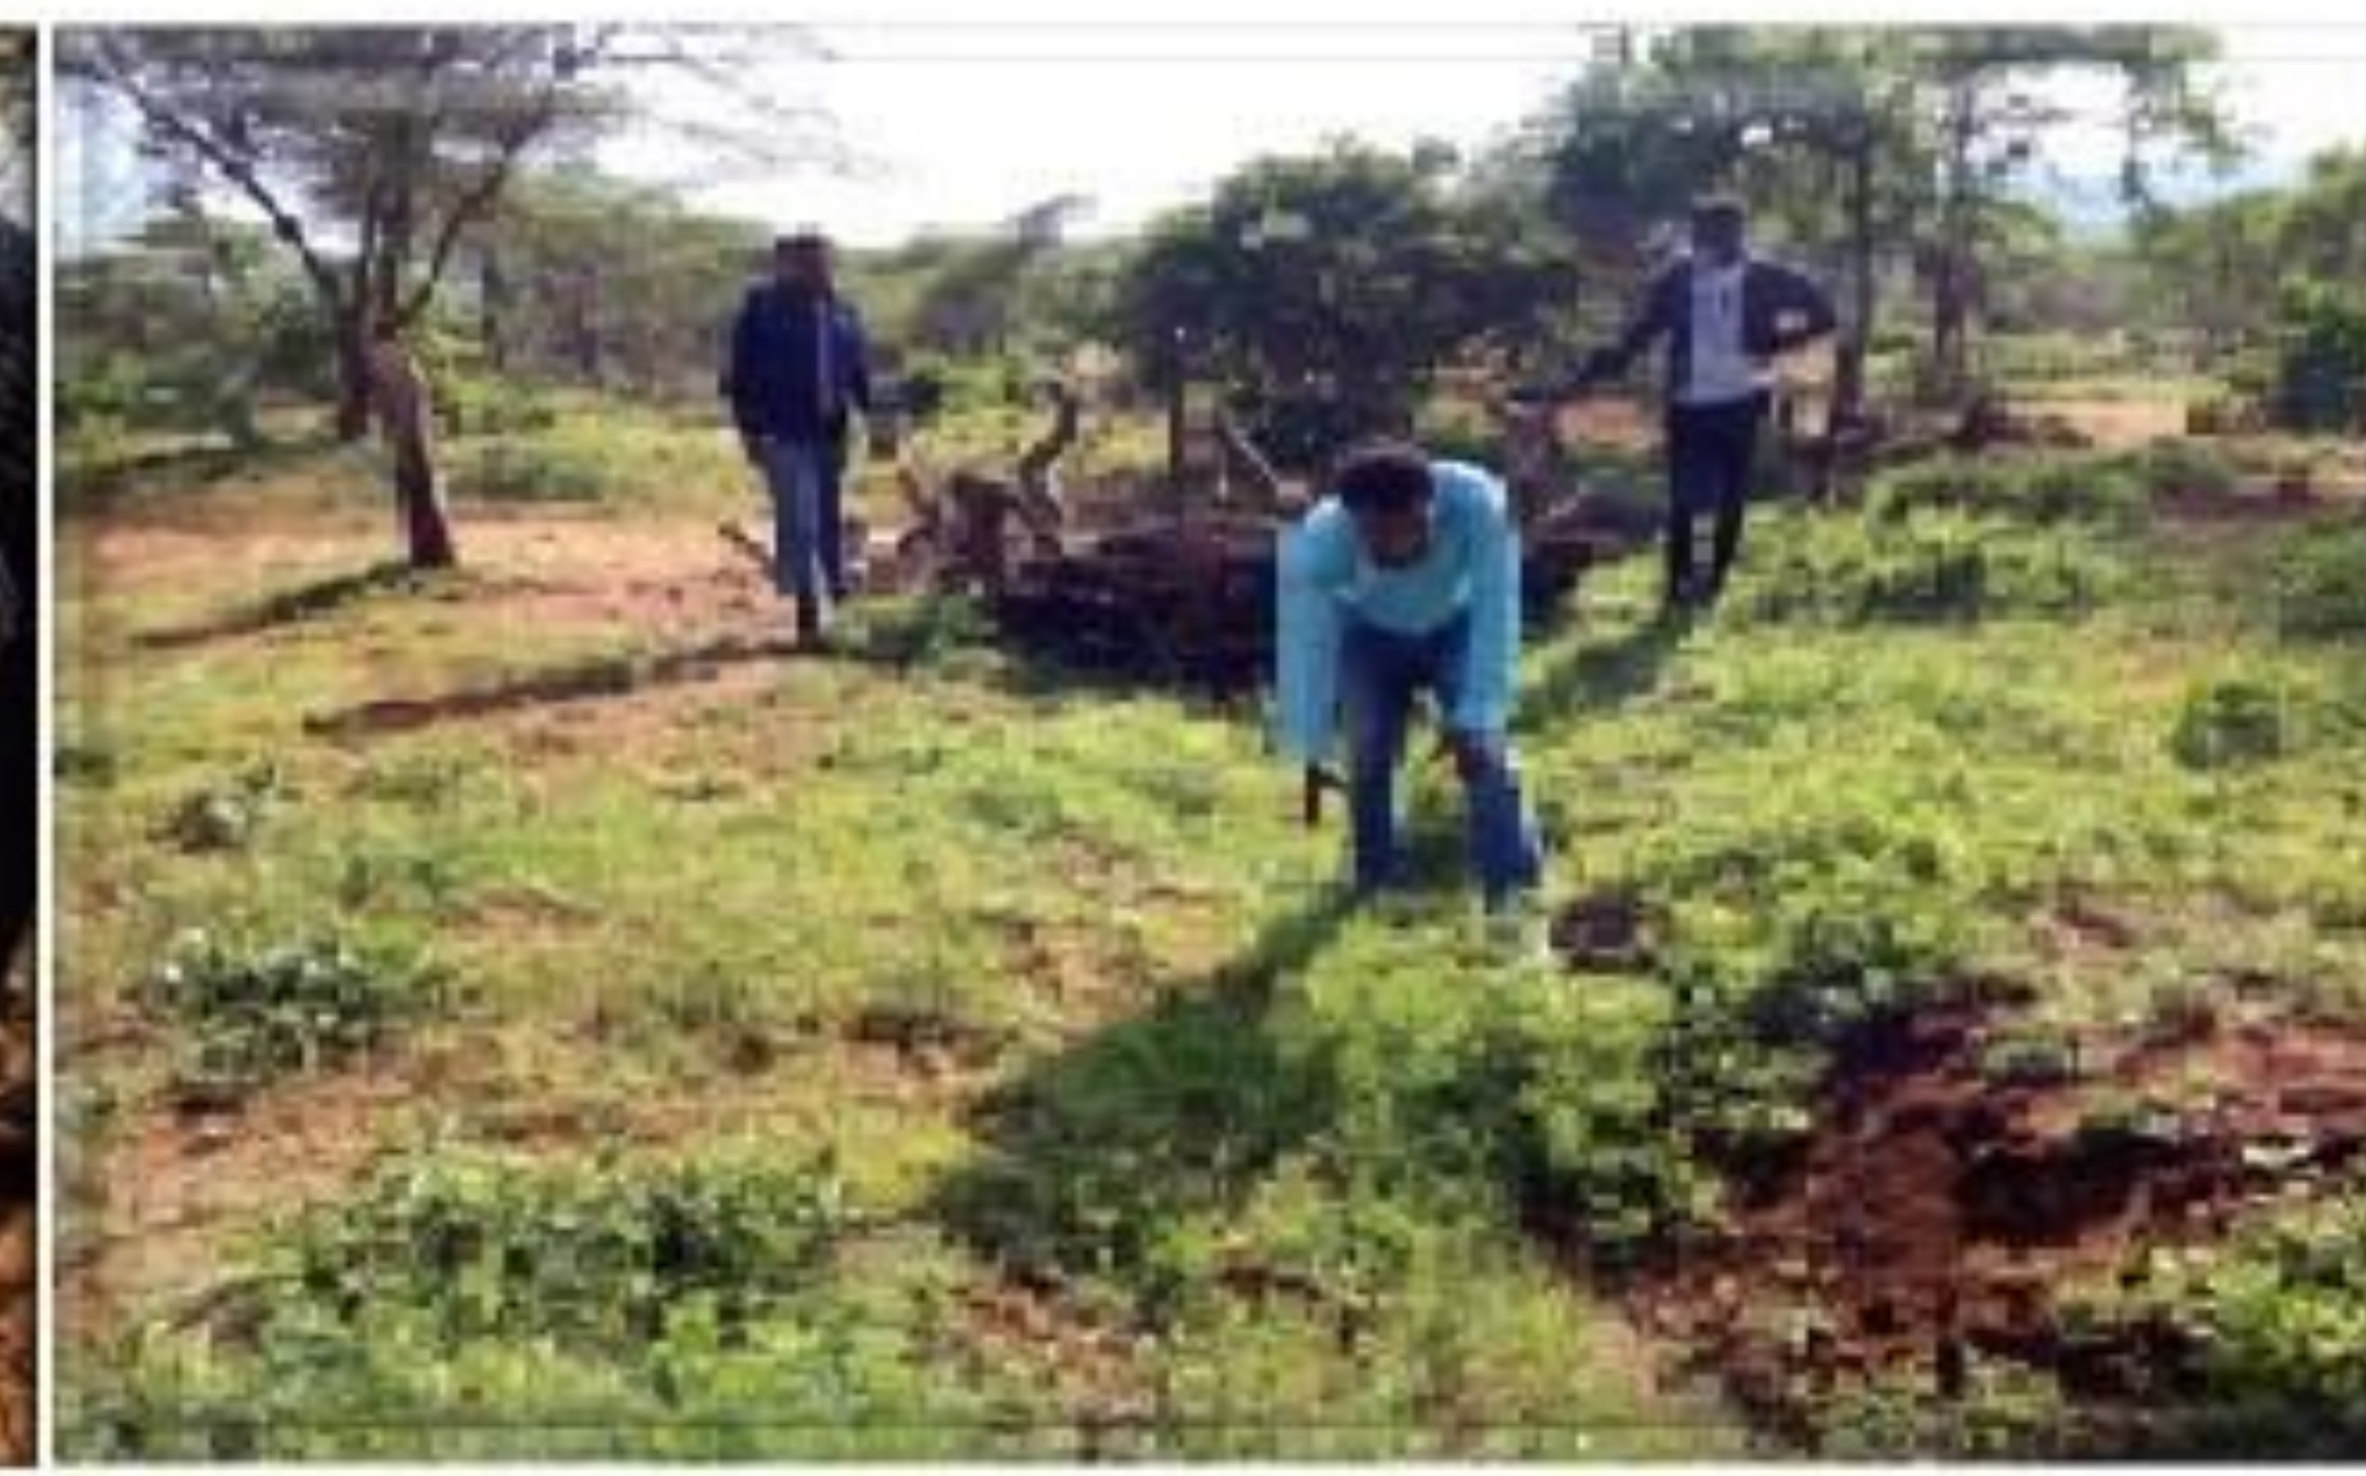
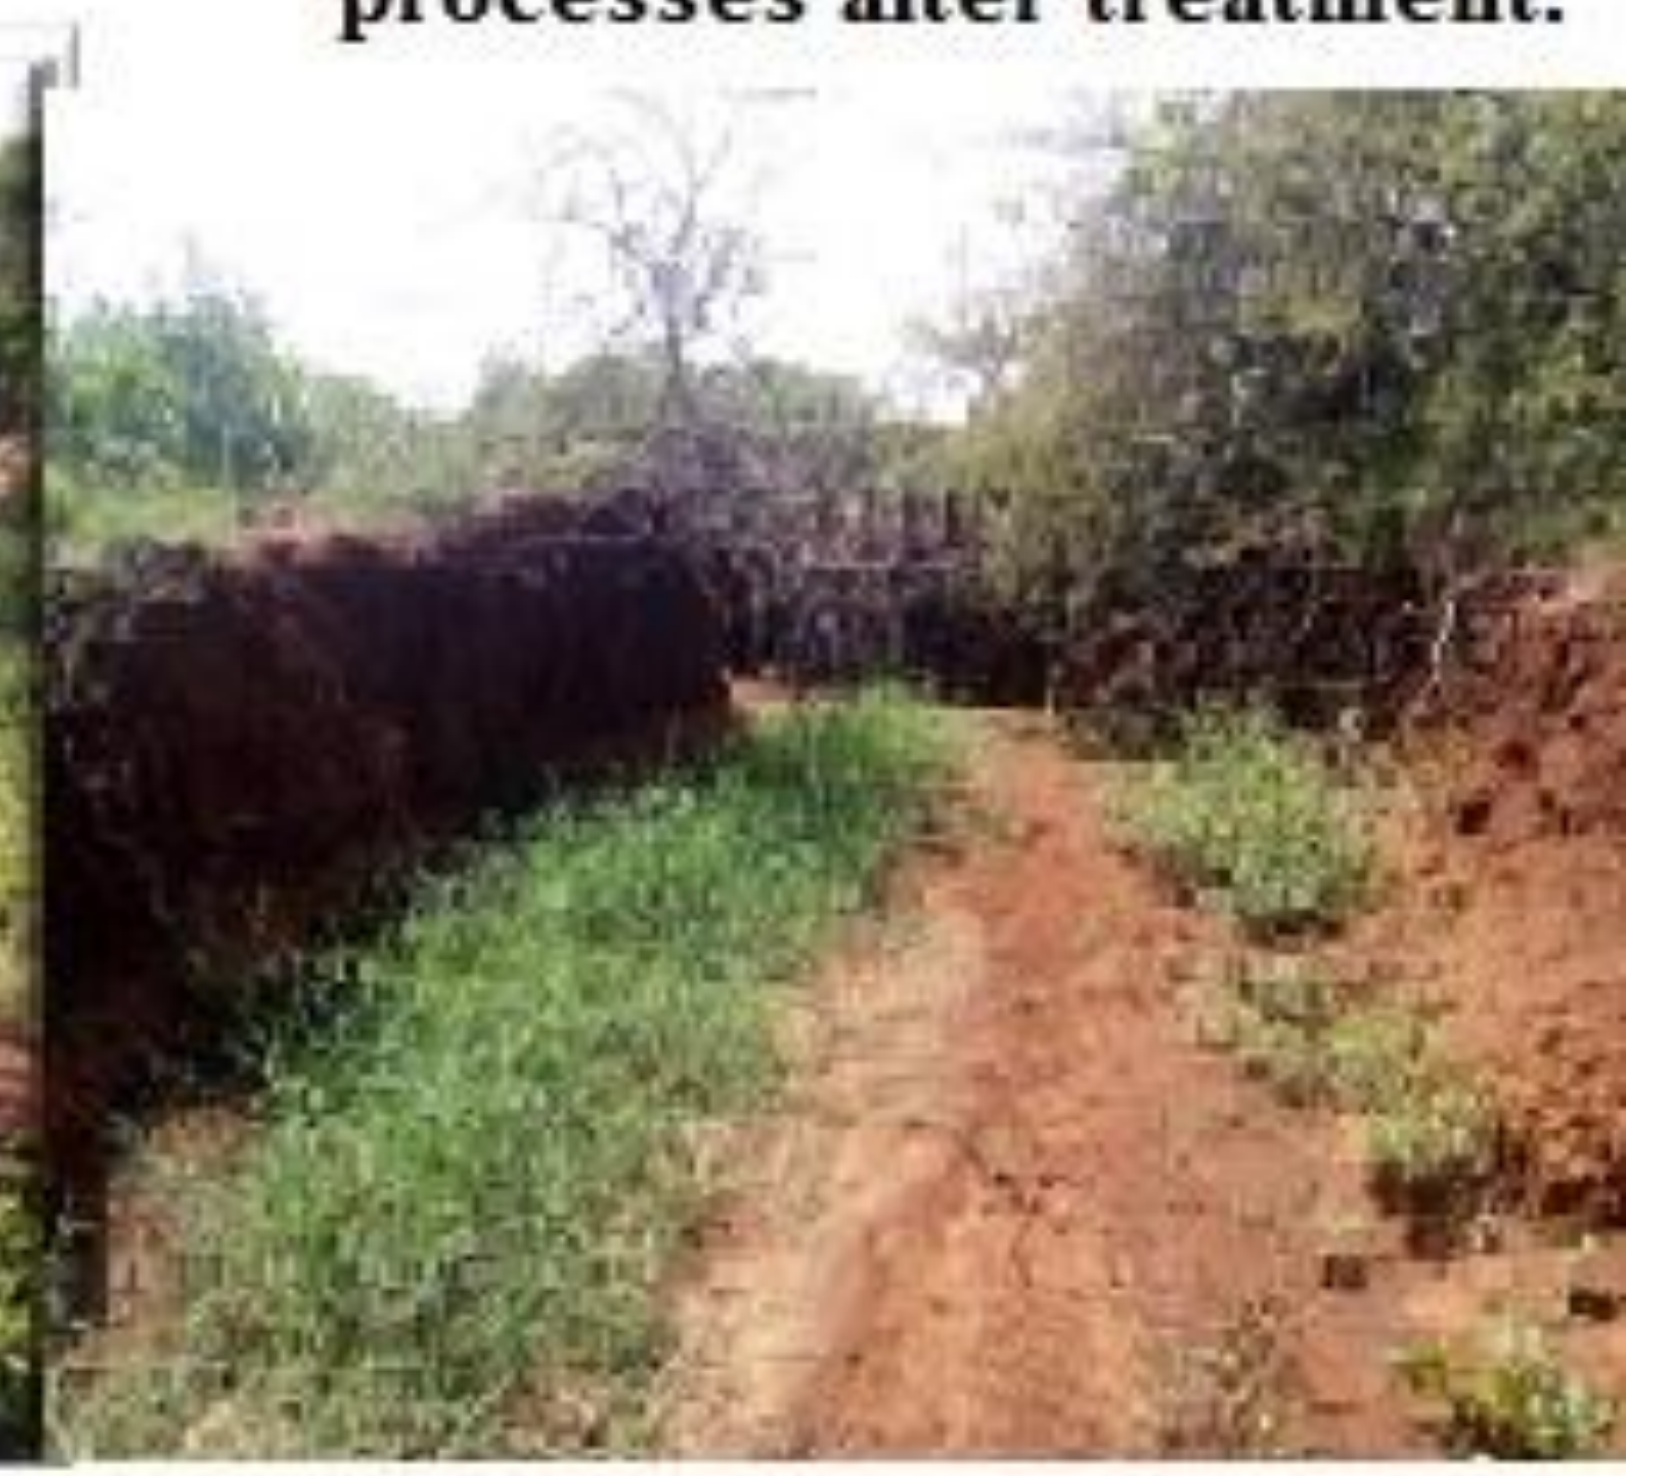
-Areas that initially had very low plant cover can experience substantial increases in cover once protected/ treated.

-Gully on the rehabilitation processes after treatment.
