Title: Erosion-control Intervention Associated With Pond Catchment Rehabilitation in Borana Plateau, Ethiopia.

First author: Demisachew Tadele (MSc)  
 Organization: Oromia Agricultural Research Institute;  
 Yabello Pastoral And Dryland Agriculture Research Center.

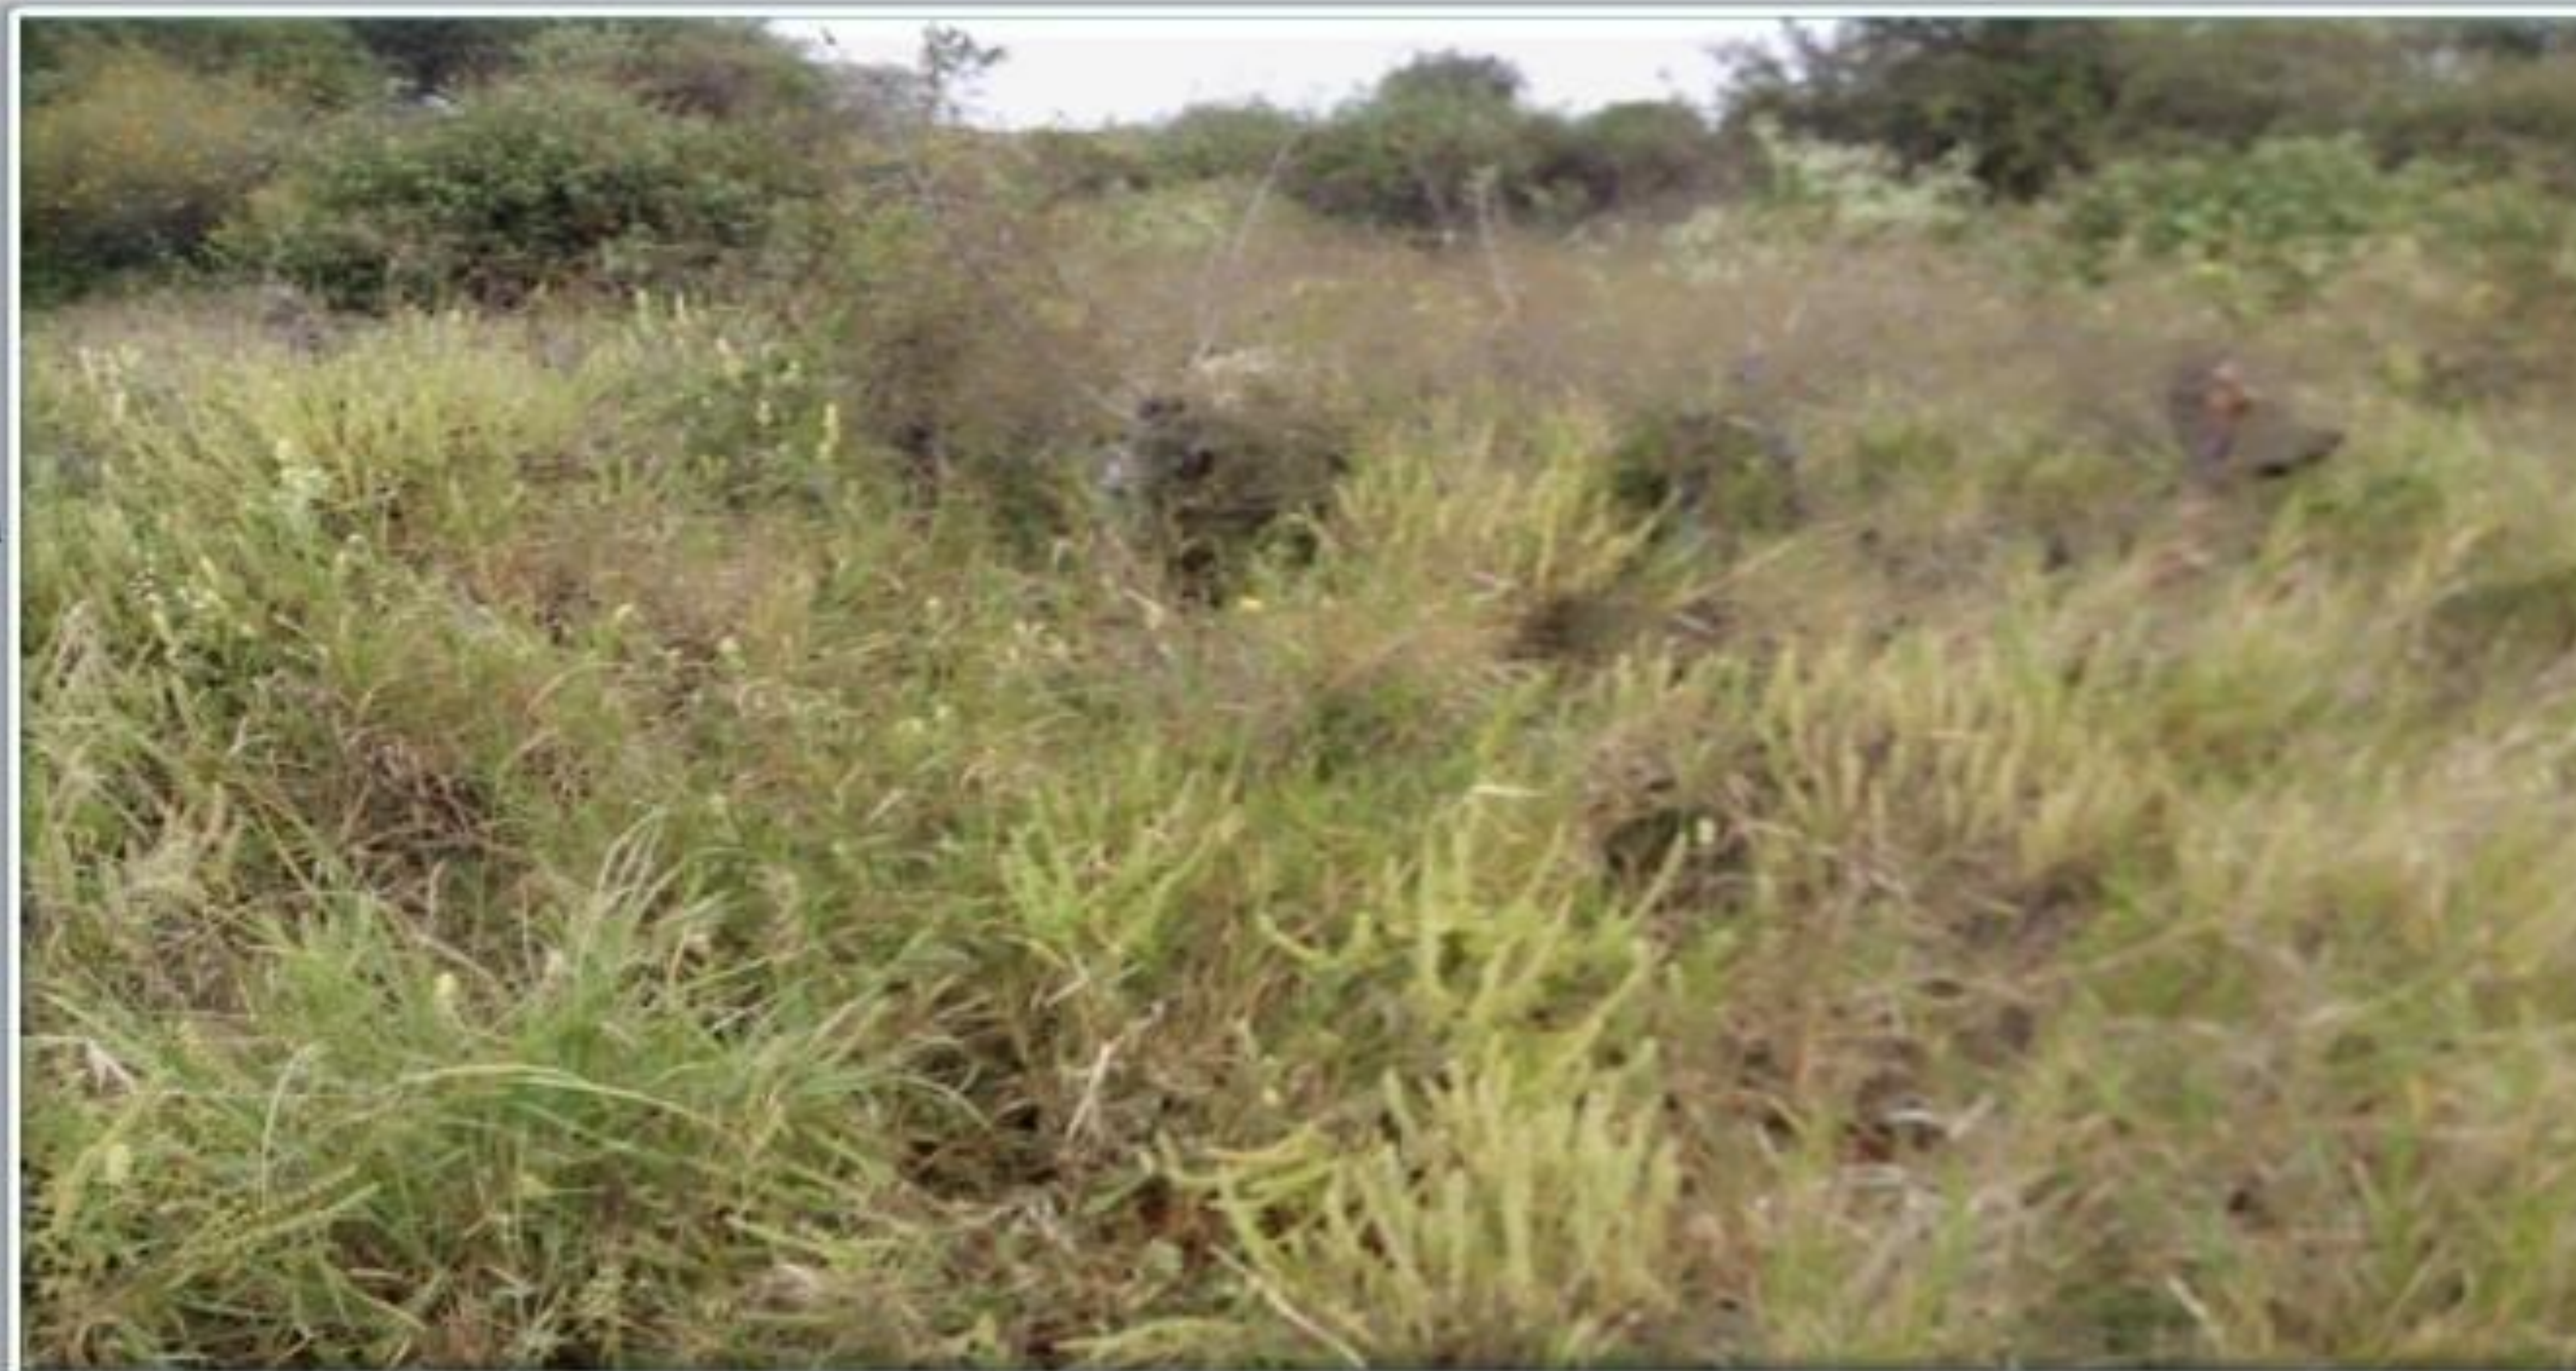
-The simple act of fencing an area to exclude livestock here for about one year caused both ground cover and ground species diversity to more than double.

- This is a conservative conclusion based on a data record that was initiated well after the improvement process had begun.

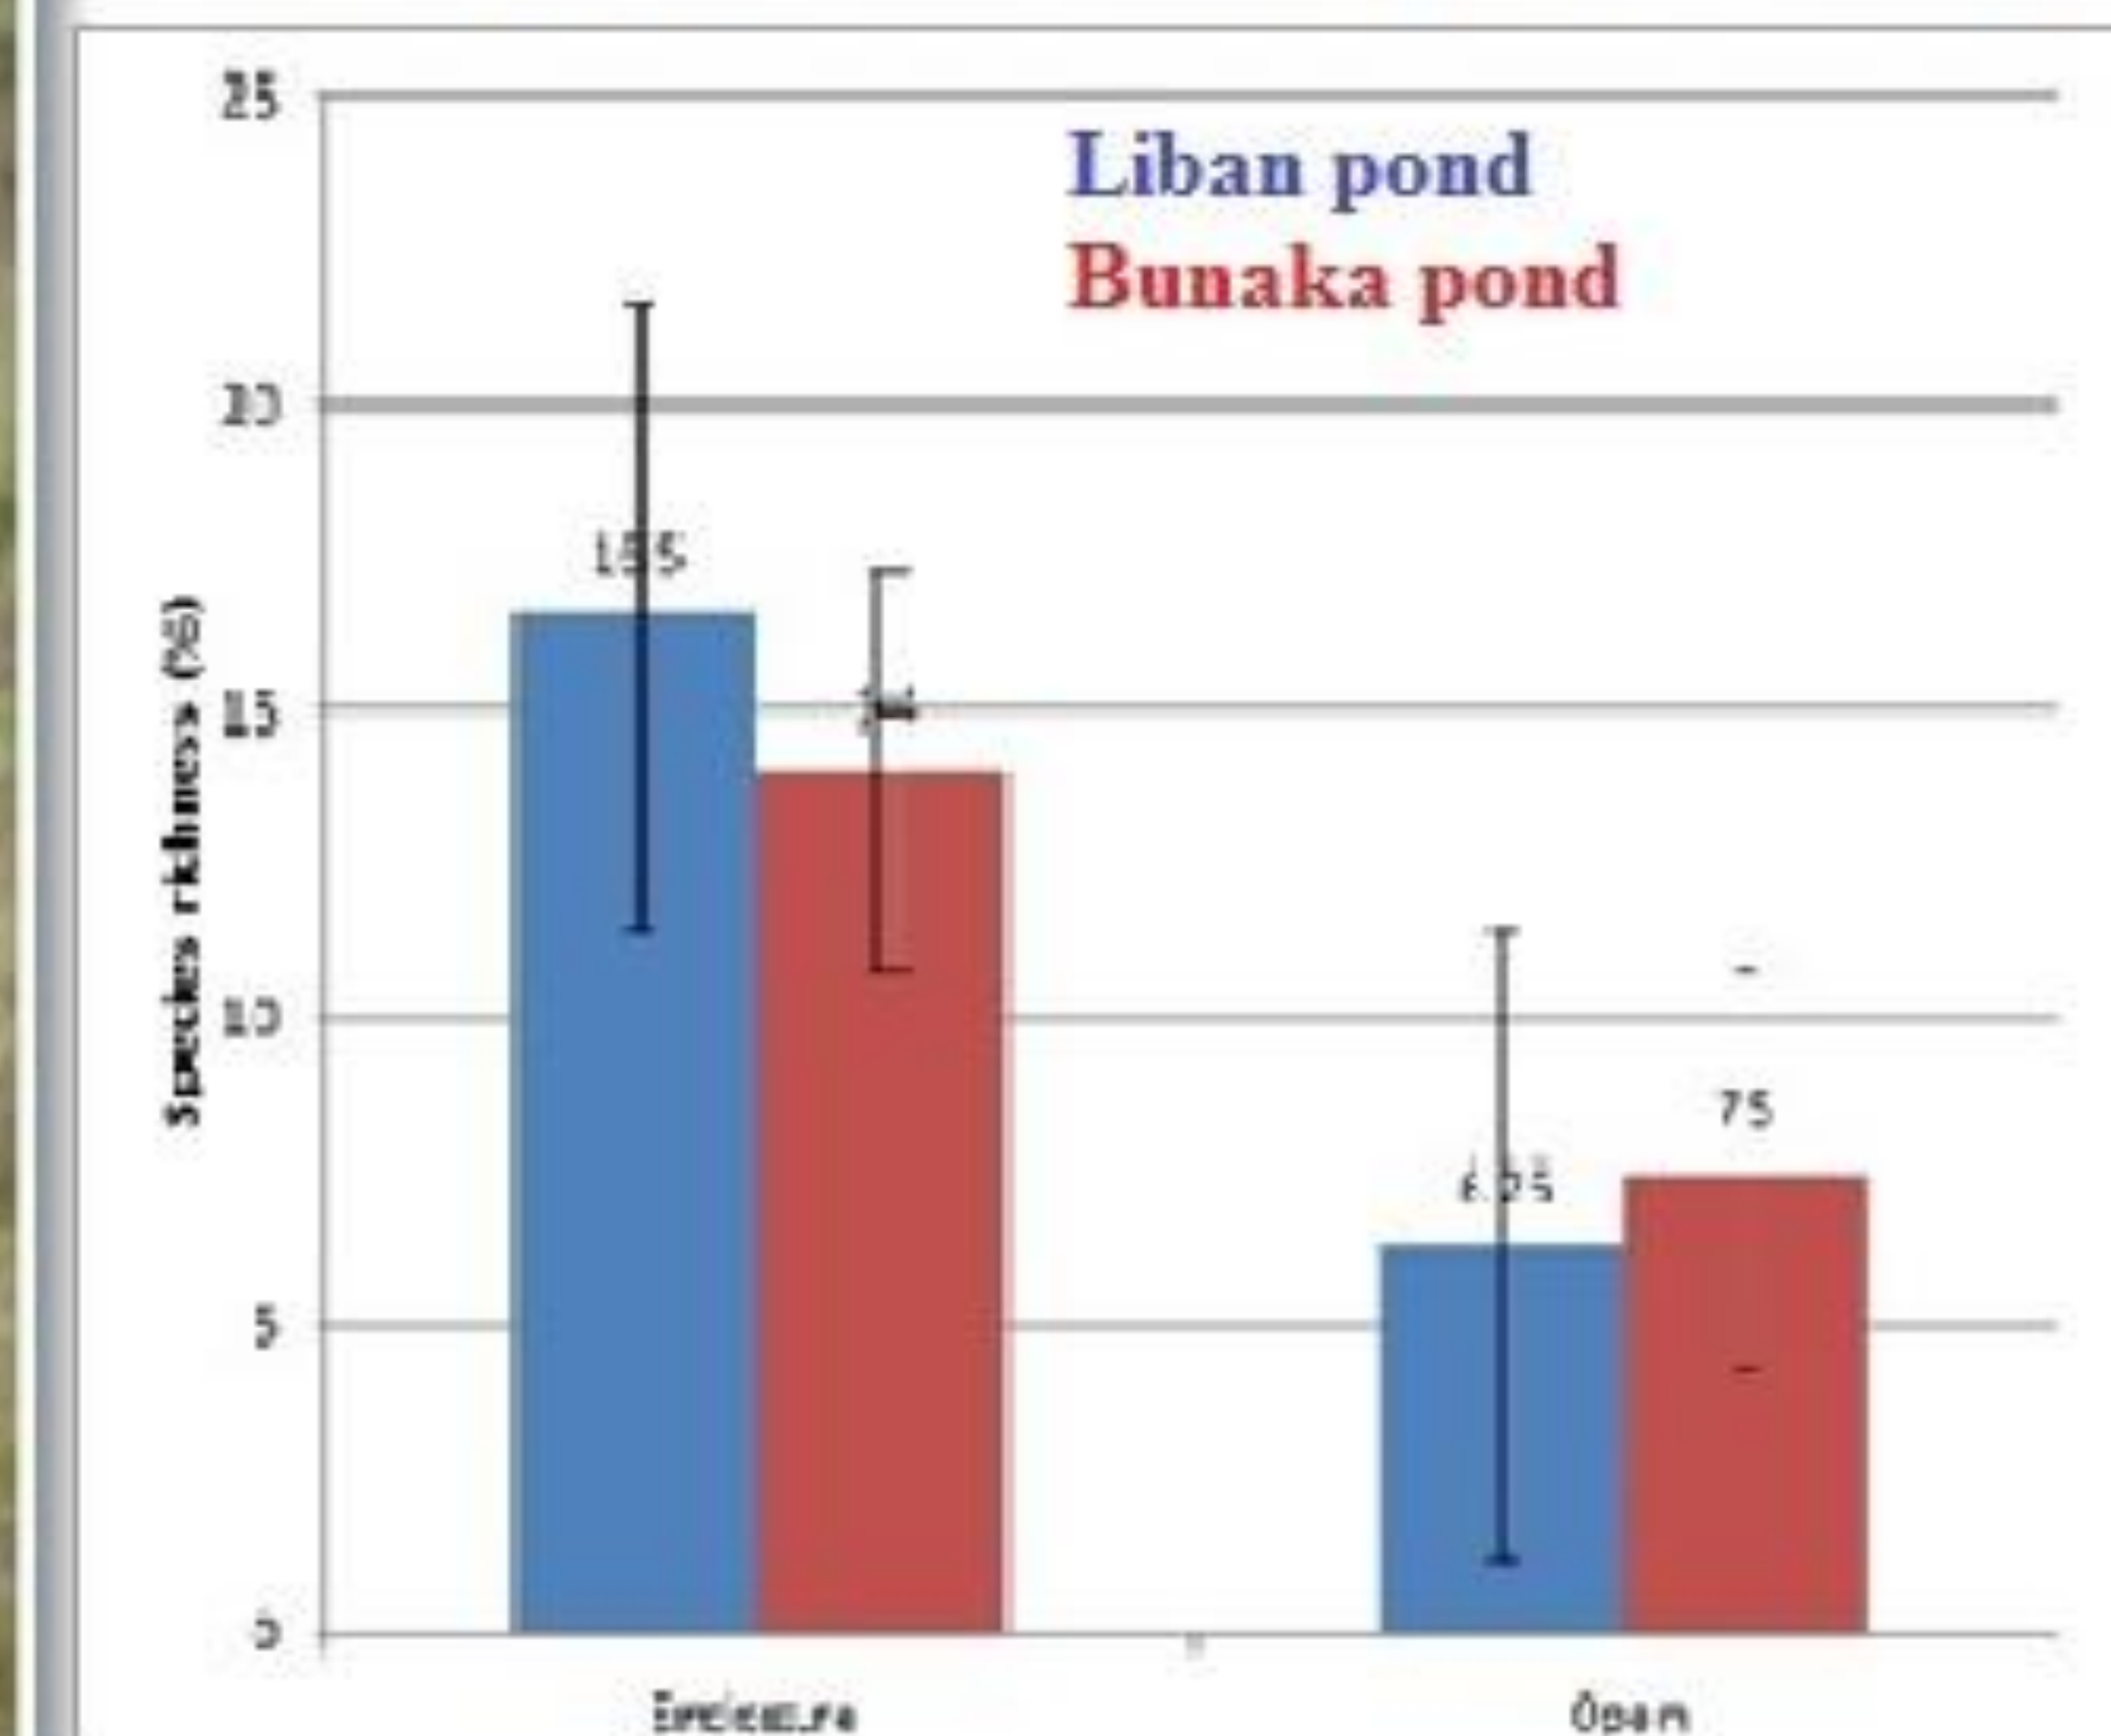
-Protecting pond perimeters from livestock grazing + sieve dam structures installation in the gully can cause dramatic increases in vegetation cover with in a relatively short period of season.
